AFTER ACTION REVIEW REPORT

COMMERCIAL BUILDING FIRE WITH MAYDAY

ADVANCE AUTO PARTS
11909 REISTERSTOWN ROAD
REISTERSTOWN, MARYLAND 21136

REPORT PUBLISHED: MARCH 15, 2024

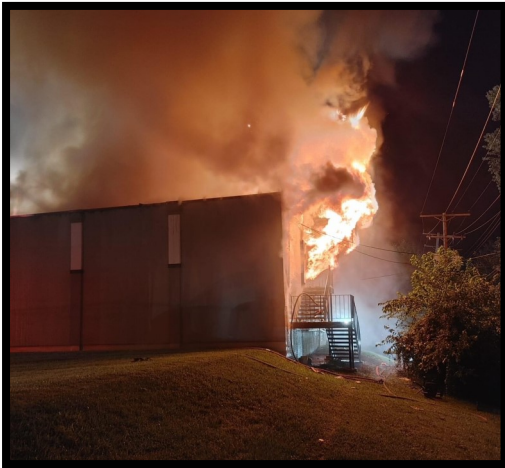
A view of the Charlie-Delta corner with the staircase to the second floor after crews had been evacuated. *Photo courtesy of Rusty Brown.*

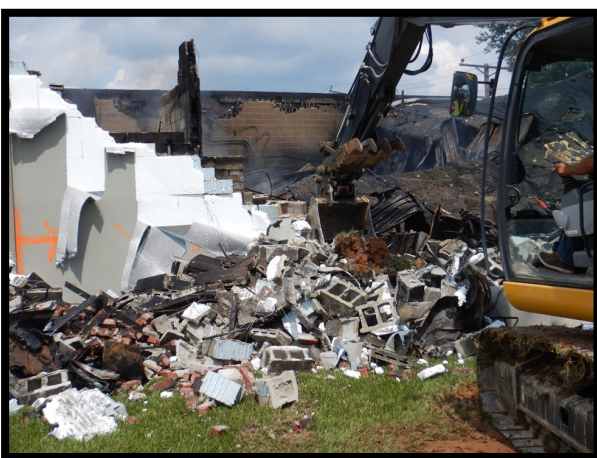
Exterior Insulation and Finish System (EIFS) over Concrete Masonry wall. The interior of the far wall is also shown.

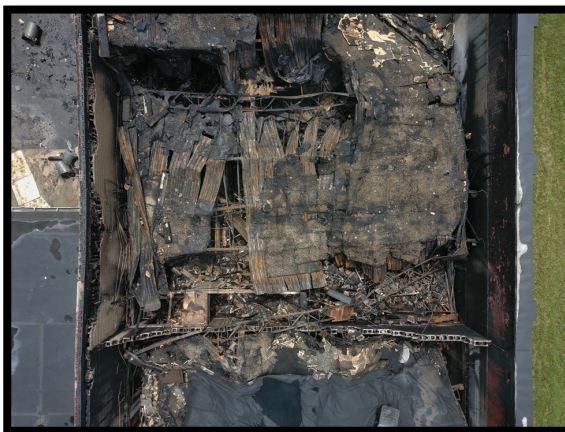
Roof elements include lightweight steel joists, metal decking, insulation, and membrane. The interior block walls bounded the main fire area.

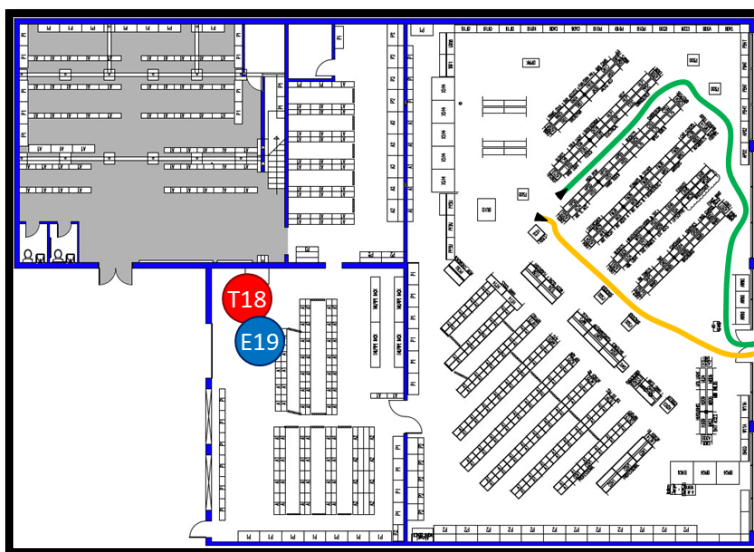
The location of Truck 18's lieutenant and Engine 19's captain when Engine 18-Driver makes contact with them. The yellow and green lines represent attack lines which had been stretched into the building.

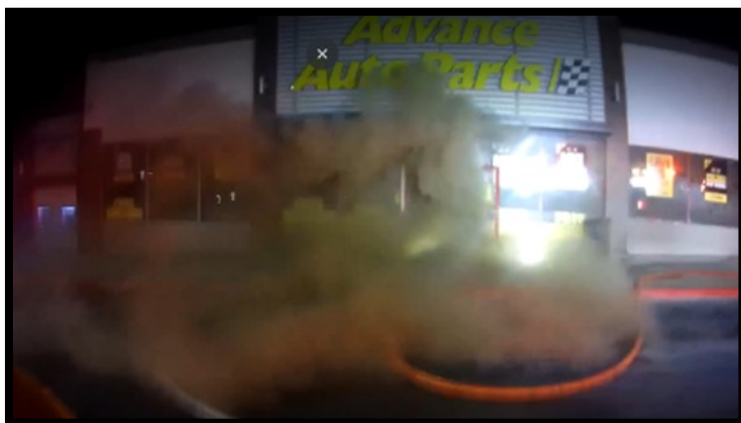
Helmet camera footage obtained shortly after the arrival of Engine 56 observing a large volume of low-velocity smoke.

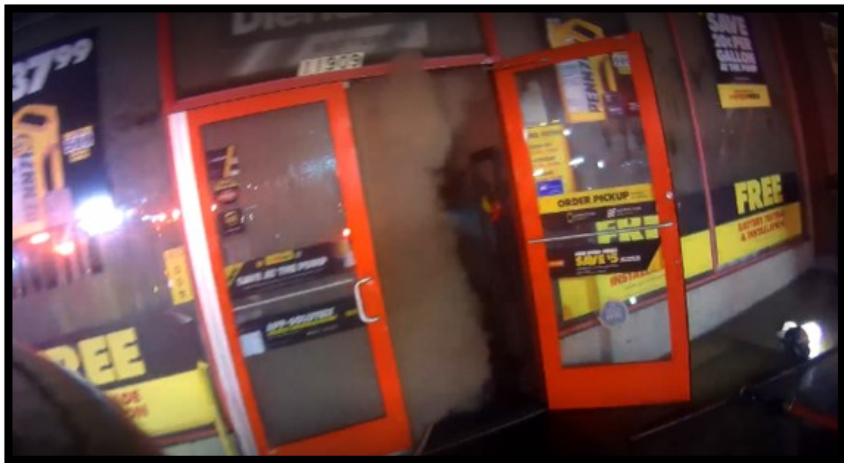
Fresh air entraining back into the structure from Side Alpha as E413 forced the door on Side Charlie.

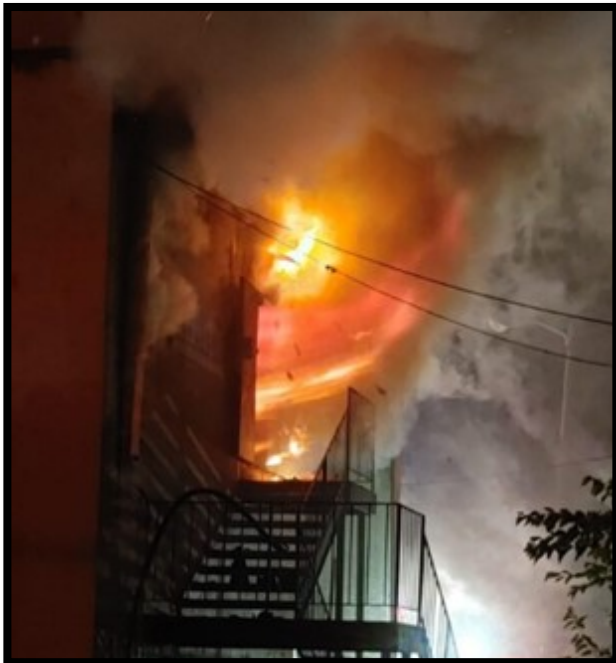
The high exhaust opening created on Division 2, Side Charlie. This photo was taken after the MAYDAY had resolved and the front windows were removed. *Photo courtesy of Rusty Brown.*

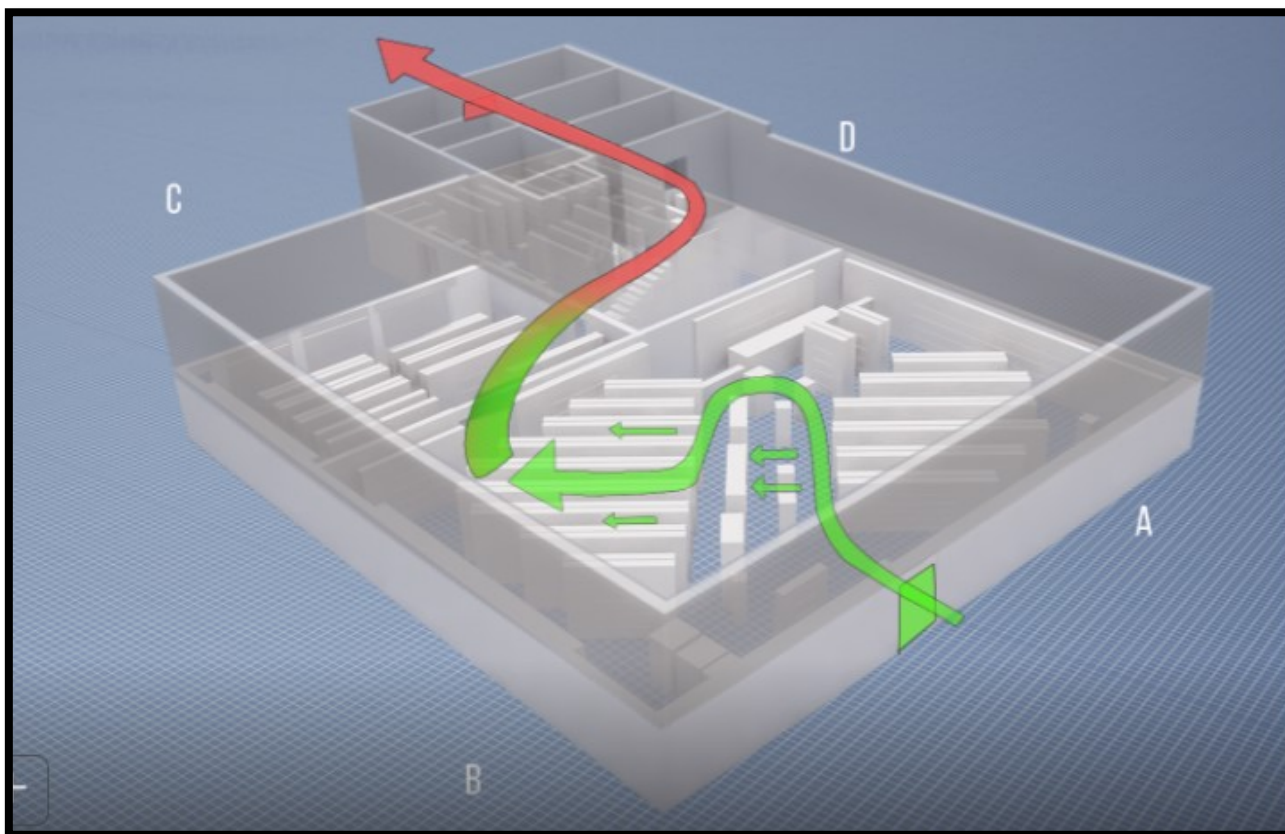
An isometric view of the structure with the flowpath overlaid. Fresh air (green) entered the structure through the open doors on the first floor of Side Alpha. The flow progressed up the second floor steps and exhaust (red) exited the structure on Side Charlie. This diagram indicates the "Low Intake High Exhaust" phenomenon.

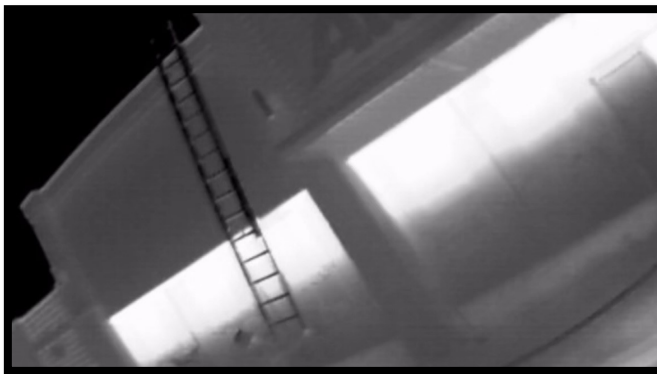
A still picture taken from T18's TIC shows clear demarcation of the thermal layers. In a wide, open space area of the store front, this is an indicator of heat that should be used to formulate a risk assessment.

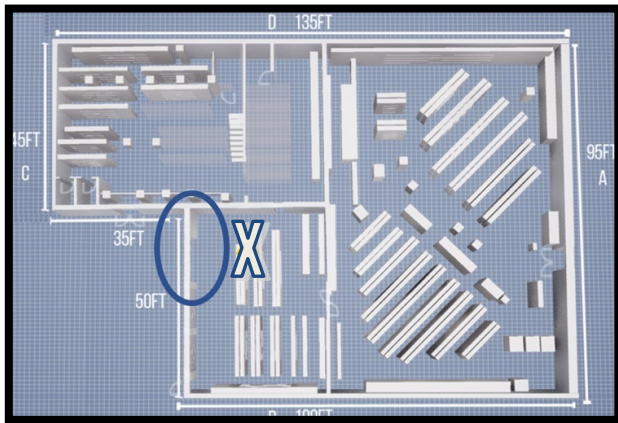
On this incident, a large roll-up door was located on Side Charlie. It is visible in the oval on the diagram of the structure. The “X” represents the location of the MAYDAY lieutenant and the RIT member who became disoriented within the IDLH. There was also an exit door within close proximity to the roll-up. It is noteworthy how close they were
