## 10-66 – Wood Grid Ceiling Collapse

**Manhattan Box 4-4 1221 - 11/30/2021**

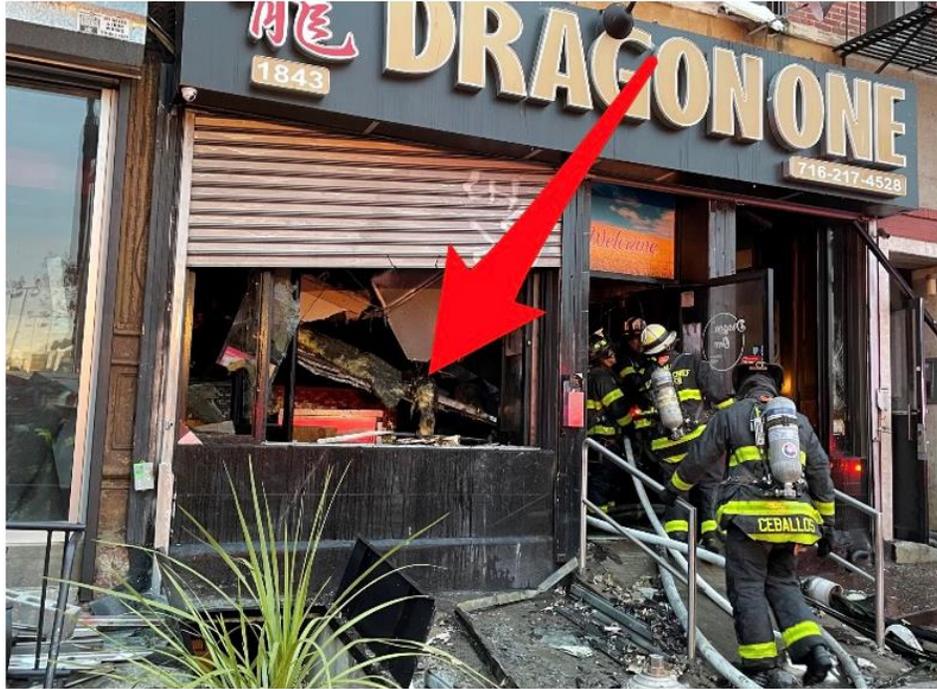
Earlier this morning several members of a truck company were trapped in the front of a 1<sup>st</sup> floor restaurant when the wood grid/sheetrock drop ceiling unexpectedly collapsed. The fire building was a 5-story Old Law Tenement that had undergone multiple alterations. There was no visible fire in the immediate area of the collapse. Fortunately, our members were quickly removed with only minor injuries. Consider the following points taken from *Collapse of Burning Buildings: A Guide to Fireground Safety*, 2<sup>nd</sup> Edition, Chapter 12, by DC Vincent Dunn (Retired).

- **Check for fire in the void above a suspended ceiling prior to entering a room.**
- **When working below a suspended ceiling, stay near large pieces of furniture that can act as shelters in case of ceiling failure.**

- Firefighters that become trapped below a suspended ceiling have very little time to be rescued before the fire and smoke reach them. The first step for the rescue of firefighters trapped beneath a suspended ceiling is to sweep the area with a hoseline and knock down the flames.

- A collapse potential also exists even if fire does not enter the void created by the suspended ceiling. Water runoff can cause a suspended ceiling to fail and fall upon those operating below.
