AFTER ACTION REVIEW REPORT

COMMERCIAL BUILDING FIRE WITH MAYDAY

ADVANCE AUTO PARTS
11909 REISTERSTOWN ROAD
REISTERSTOWN, MARYLAND 21136

REPORT PUBLISHED: MARCH 15, 2024

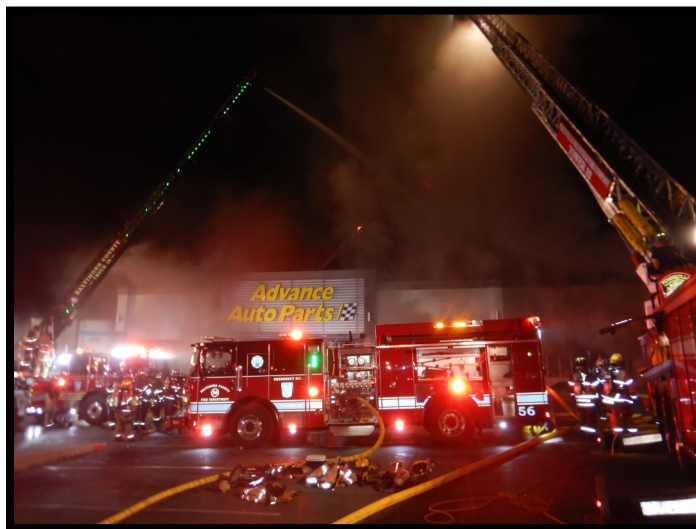
Truck 18, Engine 56, and Tower 323 (L to R) operating on Side Alpha of the structure.

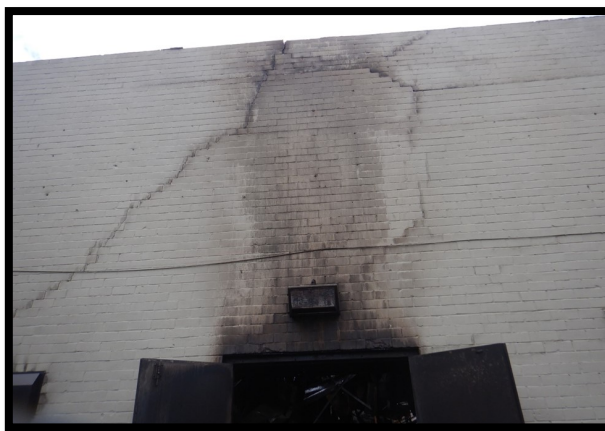
The Advance Auto Parts store involved in this incident was a roughly 12,650 square foot one-story, mercantile building with no basement of Type II-B (Unprotected Non Combustible) Construction built in the late 1970s or early 1980s. Elements used included metal framing members, unreinforced masonry unit walls with brick façade or Exterior Insulation and Finish System (EIFS), metal cladding, and unprotected open-web joists. The flat roof was supported by

A post-incident photograph of the building's brick façade.

lightweight steel roof trusses, which were covered with metal decking, insulation, and a waterproof membrane. At some point, second-story office space was added to the Charlie-Delta corner of the building, with exterior egress stairs exiting to the Side Charlie. The floor of the second story was composed of exposed wood joists with a wood subfloor supported by unprotected steel columns. The internal stairs leading to these offices were steel with partial/limited fire protection underneath. Post-fire photographs revealed that wood framing and wood furring strips were used in the construction of the second-floor partitions.

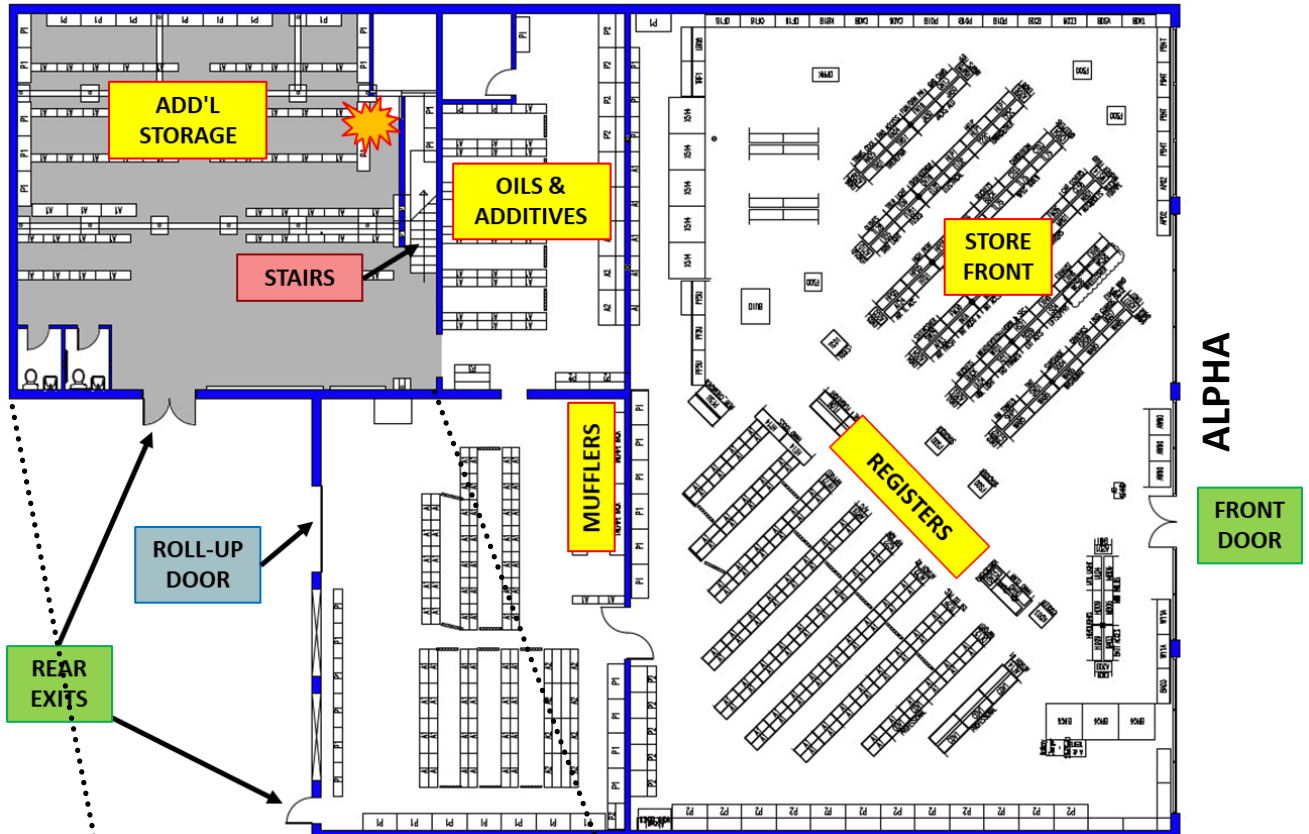
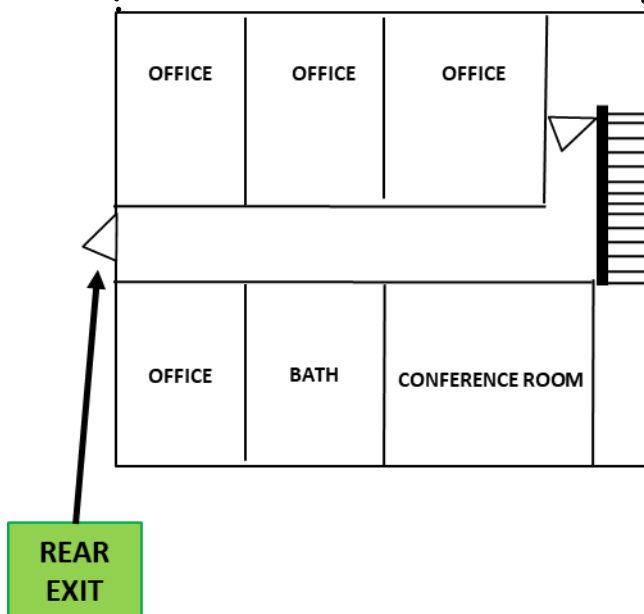
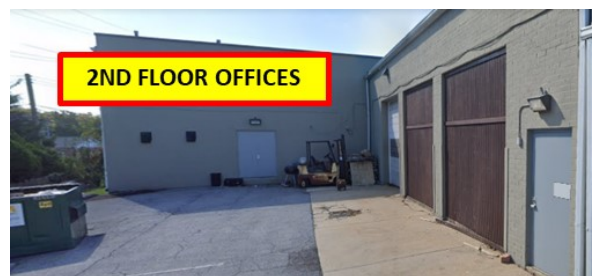
This composite view shows the first floor plan with approximate location of store inventory, the second floor office plan, and an exterior view showing the general location of the second floor.

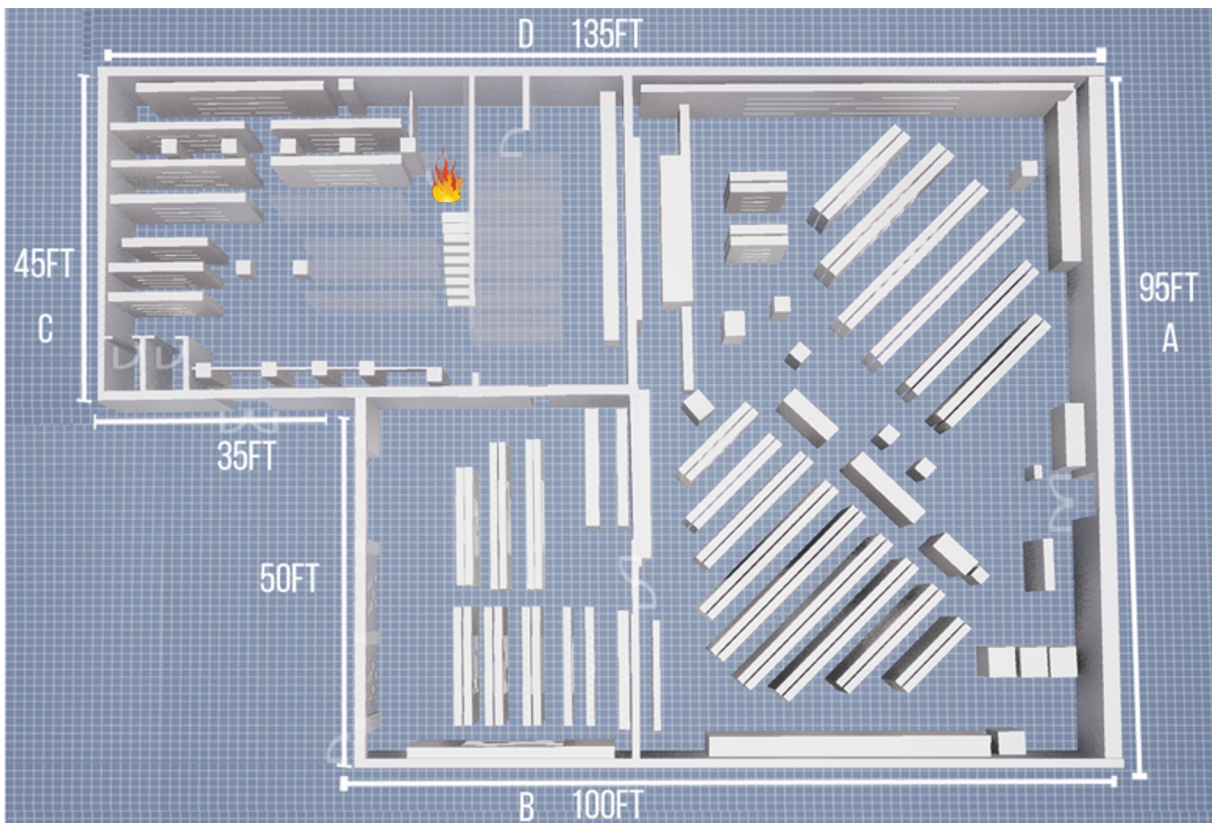
(Below) An isometric overhead view of the first floor plan with the location of the point of origin.

On July 18, 2023, at approximately 21:14, an employee of the Advance Auto Parts (located at 11909 Reisterstown Road), intentionally ignited a fire in the rear stock room of the business. The fire was started in a large storage area closet near the Charlie-Delta corner and in close proximity to a second-floor stairway. This area contained several containers of ready-to-use 2-cycle and 4-cycle synthetic fuels for power equipment, among other combustibles.

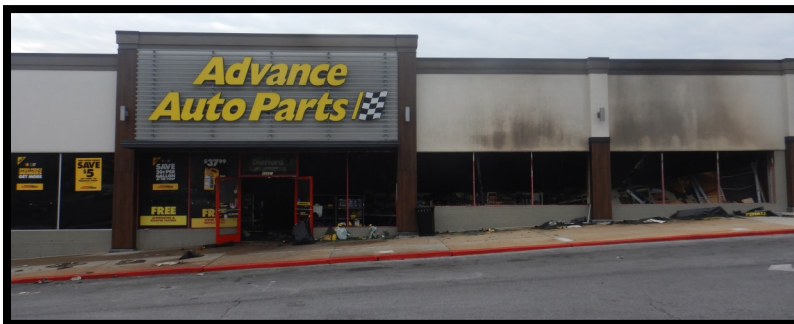
A post-incident photograph showing Side Alpha of the structure.

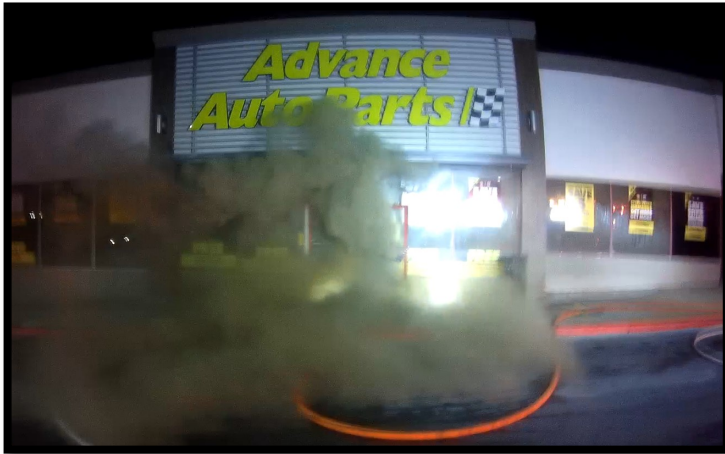
Helmet camera footage at 21:47:52, approximately 7 minutes after Engine 56 had arrived.

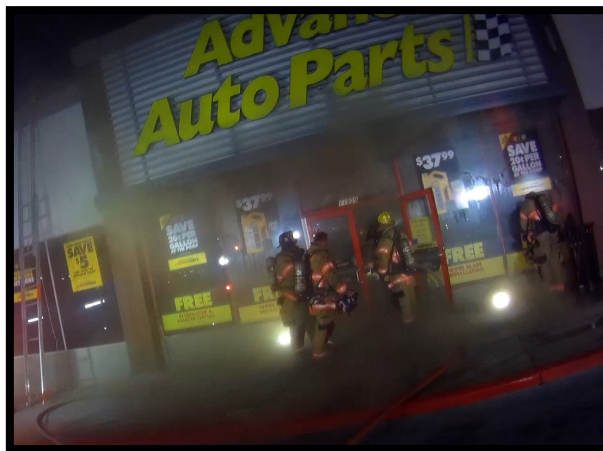
The crew of T18 preparing to make entry at 21:50:56. The MAYDAY lieutenant is on the left.

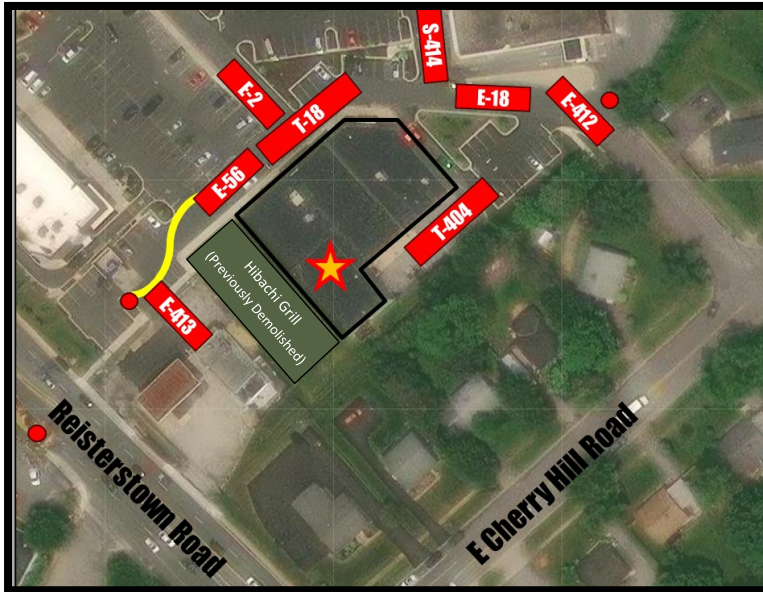
Apparatus positioning on the fireground. The star is the approximate location of the point of origin.

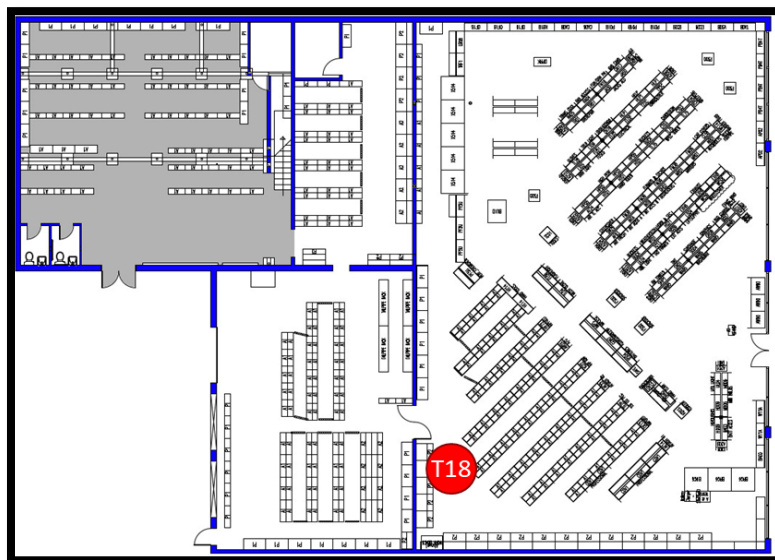
The location of the lieutenant on T18 in the building when the MAYDAY was declared. He remained in this general location when the captain from E19 made contact with him.

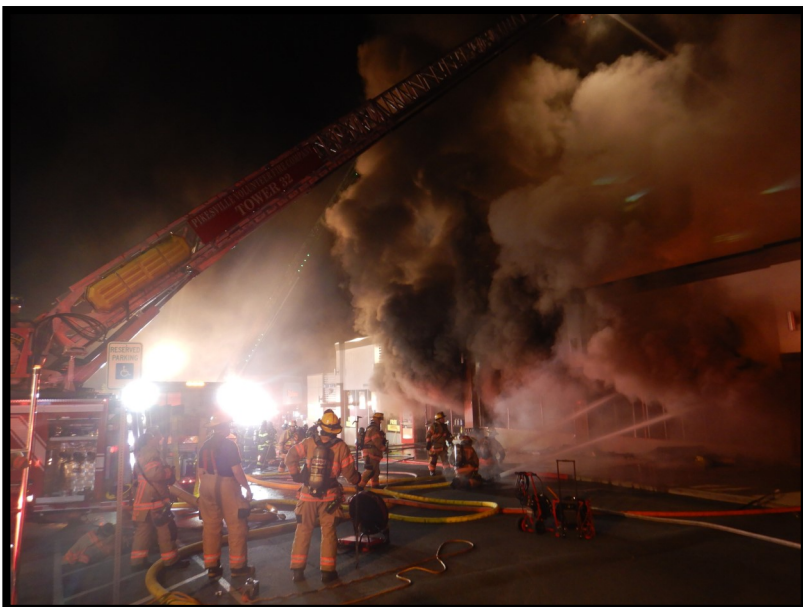
A photograph taken after the MAYDAY had been resolved.

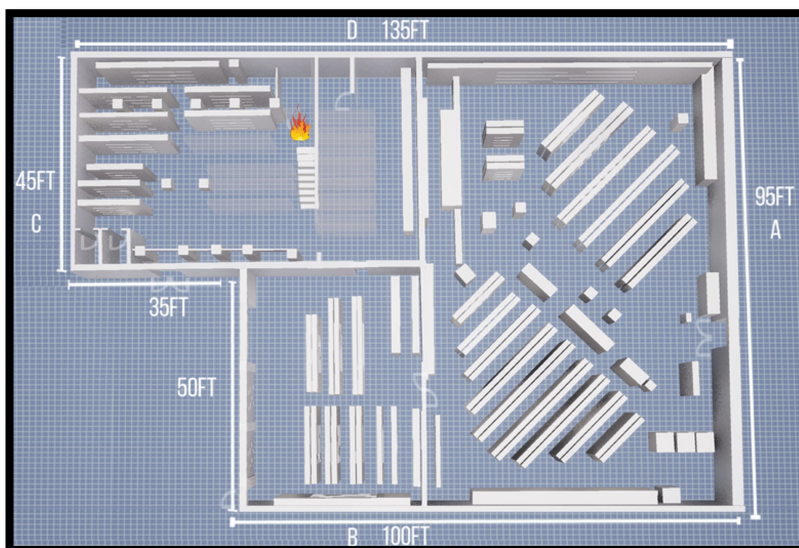
Based on the origin and cause investigation, the fire on this incident was intentionally set in a storage area near the stairs that accessed the hallway to the office area on the second floor. This location is depicted by the fire icon in the schematic to the right.

An isometric view of the Advance Auto Parts building. The front of the building (Side Alpha) is on the right side of the drawing. The fire's point of origin is depicted by the fire icon near the Charlie-Delta corner.

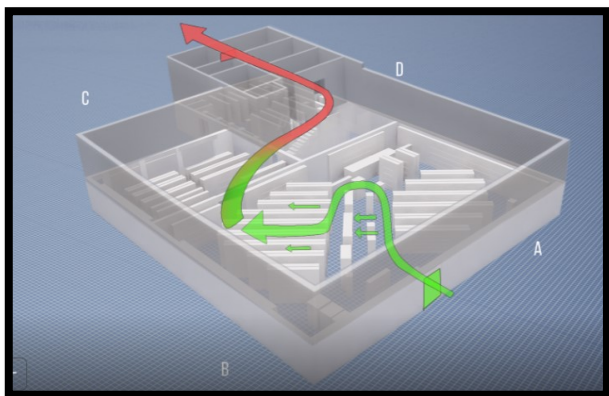
On this incident, a clear flow path was noted when the rear door on the second-floor office area was opened. This was supported by helmet camera footage and reports from Side Charlie. The smoke, which initially pushed out of the front door opening, began

to entrain into the structure. A fire dynamics assessment suggests that the front doors became a low, fresh air intake and the rear door provided a high exhaust for the increased combustion that was being fed by the influx of fresh air. Crews reported intense heat on the second floor during this time. It was noted that this drastic change was not reported to the incident commander in real time. This flow path could have been

controlled by closing the Side Alpha doors to reduce the heat release rate of the fire. This would have changed the flow path so that both the intake and the exhaust flow would have been through the open doorway on the rear.

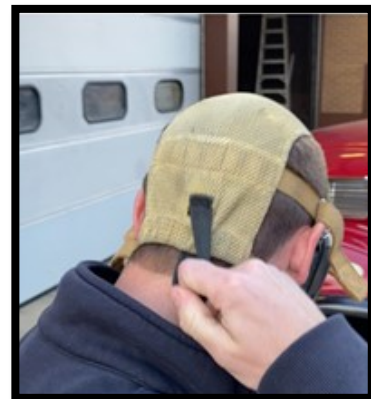
On this incident, the MAYDAY lieutenant stated during the interviews that his face piece seal was checked prior to entry. It is not clear if he donned the ensemble consistent with these recommendations. Nonetheless, the initial transmission from the MAYDAY lieutenant when he was in distress was choppy and difficult to understand. This is an indication of a poor face piece seal.

Recommendation: The After Action Review Team recommends that the Department reinforce the proper donning of the facepiece in training that takes place in the future. The skill must also be reinforced when members conduct their yearly required fit-test.

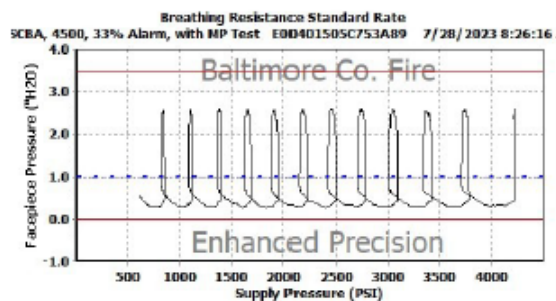
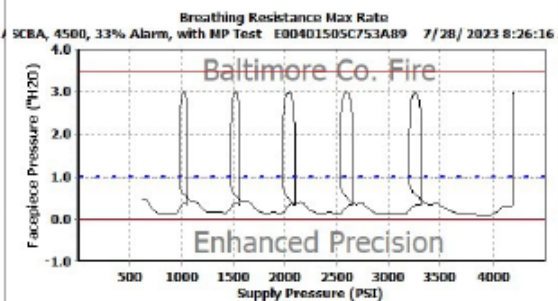
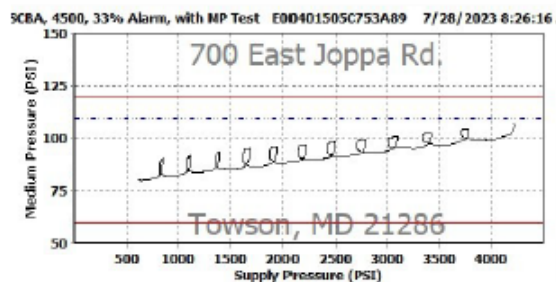
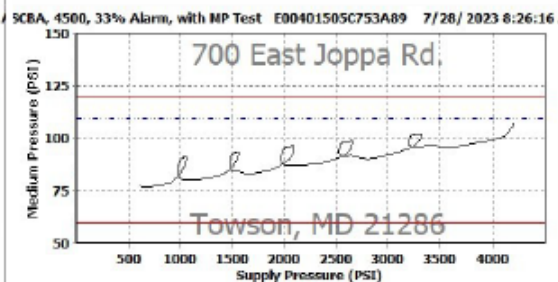
Auxiliary IDs		Functional Tests			
Facepiece		Exhalation Pressure	Pass	2.3	"H2O
Second Stage		Facepiece Leakage	Pass	0.1	"H2O
First Stage/Reducer		Static Facepiece Pressure	Pass	1.0	"H2O
Low Pressure Alarm		Static Medium Pressure	Pass	109.1	PSI
Cyl Connector		Medium Pressure Creep	Pass	0.9	PSI
Airline Attachment		1st Breath Activation	Pass	-5.1	"H2O
Harness		High Pressure Leakage	Pass	2	PSI
Visual Inspection		Bypass Pressure	Pass		
Facepiece	Not Perform	Alarm Activation Pressure			
Backframe/Harness	Pass	G1 4500 Bell (33%)	Pass	1563	PSI
Cylinder	Pass	Ringdown	Pass	95	PSI
Low Pressure Warning	Pass	Gauge Accuracy			
Hoses	Pass	4500 PSI Numbers			
Manifold Volume: 0.077		1000±225 PSI	Pass	882	
		2000±225 PSI	Pass	1835	
		3000±225 PSI	Pass	2841	
		G1 4500 HUD (33%)			
		Pass			
		33% (1575±90 PSI)	Pass	1510	
		50% (2250±225 PS	Pass	2196	
		75% (3375±225 PS	Pass	3307

7/28/2023 8:57:25 AM - Bill Connelly: Inspection and flow test of G1 T1805 following incident# 231992034. Performed MSA
