# FIREFIGHTERCLOSECALLS.COM

## NIOSH FF Fatality Report 2014-15

On July 9, 2014, Firefighter Daniel Groover of the Houston (TX) Fire Department died in the line of duty while conducting interior operations at a two-story residential structure fire.

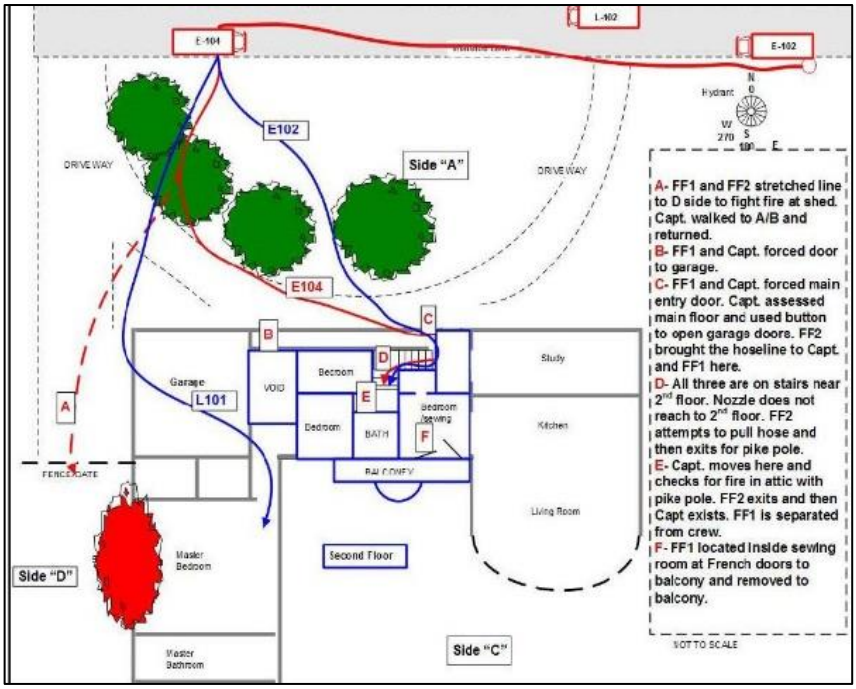
At 1555 hours Engine 104 was dispatched for a reported shed fire. Upon arrival they observed fire and black smoke from Side C and D of the structure and the Captain requested a box alarm. The crew reported hearing ammunition going off while they advanced a 1 ¾" hoseline. The Captain and FF Groover forced entry to the front door and after only observing minimal smoke and no visible fire or civilians, proceeded to a narrow stairway to the 2nd floor.

FF Groover, the Captain and another Firefighter went to the top of the stairs and began searching for civilians and fire. After the Captain heard one of the Firefighters say that they were getting hot and low on air, backed the crew down the stairs. It was then realized that FF Groover was missing. Going back to the 2nd floor the Captain heard a PASS device in the room to his left, notified the Incident Commander and then had to back out due to being low on air.

Engine 63 made entry through the rear double doors off the deck on the 2nd floor and located FF Groover just inside the double doors. He was taken down a ladder to the yard and was then transported to the hospital where he died from his injuries. He was 46 years old and had a wife and 3 children.
